A Light in the Darkness – the Taper Burns of Donington le Heath Manor House

Alison Fearn

PhD Candidate, University of Leicester

Summary

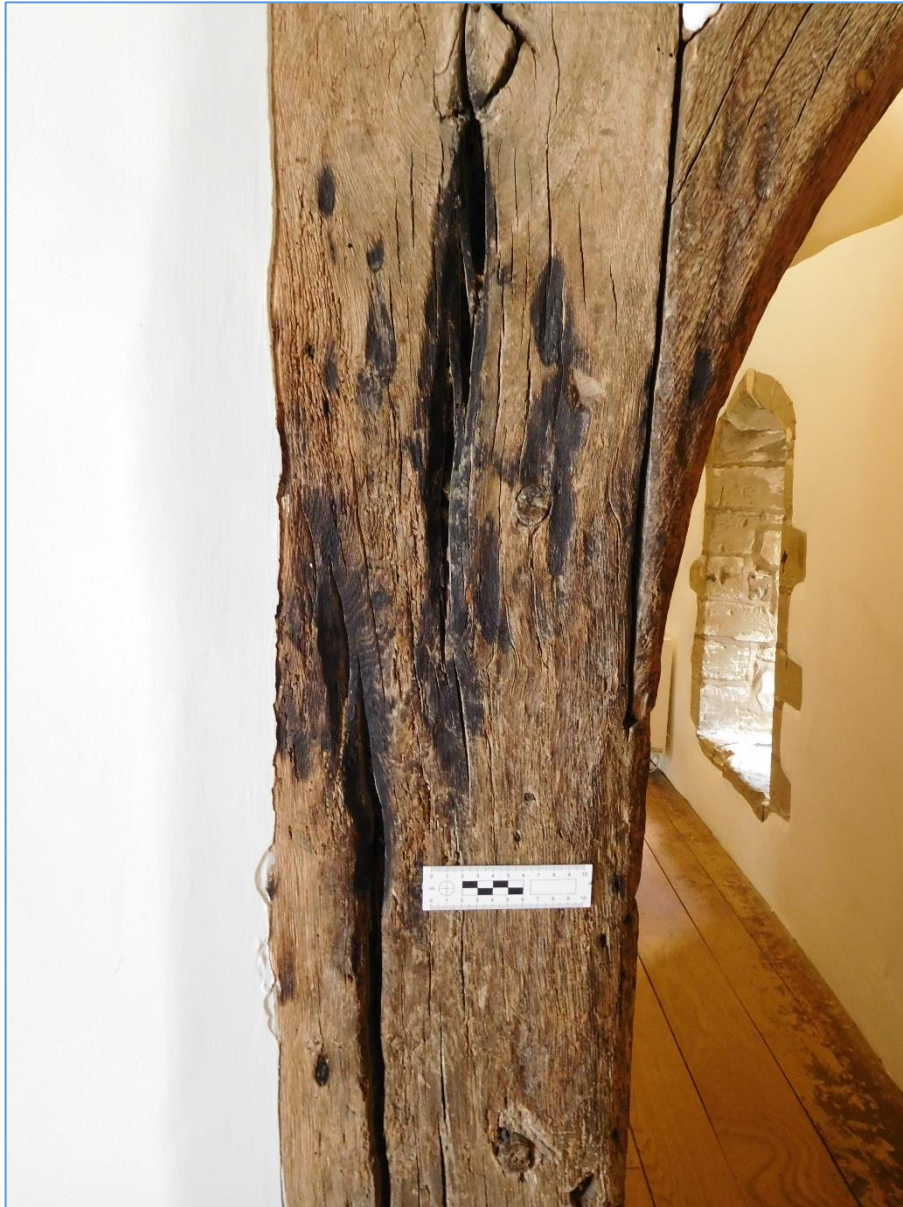
Figure 6 West doorway taper burns facing into Great Hall, Donington le Heath, Leicestershire. Photo: author.

The western-most doorway divided public and private space circa 1300-1600. The highest concentration of scorch marks/burning episodes are to be found on the jambs facing into the public area of the presumed Great Hall (current museum interpretation is of a Great

Chamber as the house is fixed in time to 1620 and displayed as an early 17th-century domestic dwelling). The doorway originally separated the Great Hall from a suite of two private rooms, most probably a bedchamber and solar before the 1618 improvements. There are between seventeen and twenty separate scorching events, the majority on the western-most side of the door jamb. These predominantly follow the classic teardrop shape -- the typical form for these sorts of burns, and further work is required to determine whether the

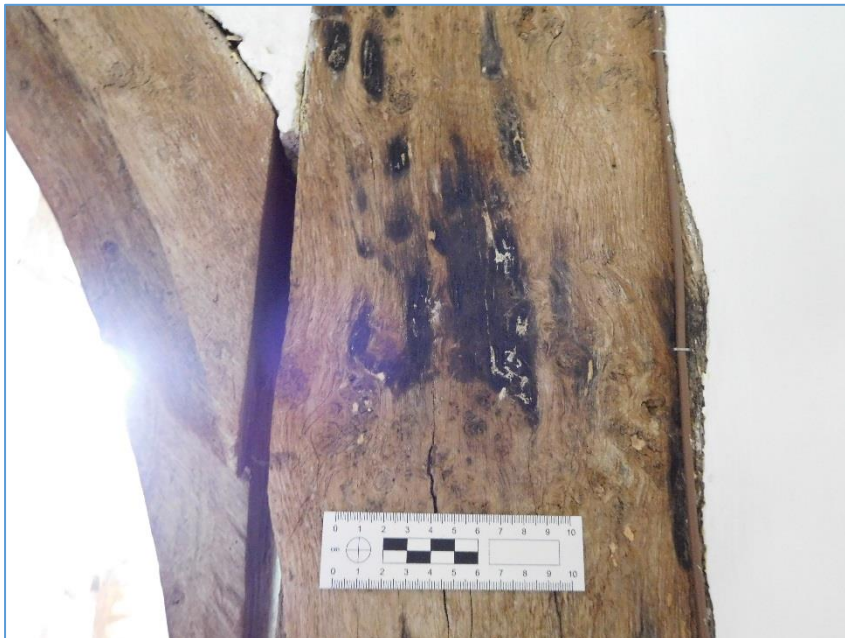
Figure 7 Taper burn west doorway facing Great Hall, Donington le Heath, Leicestershire. Photo: author.

shape itself may hold some significance.²⁰ Two of the burns are atypical, and are long scorch marks which cross seasoning cracks within the timber, and the depth of burn is deep, with hardened charcoal residue remaining in situ. These marks would have been highly visible to people within the Hall itself. The doorway into the second room is a 20th-century replacement with no surviving medieval or later timber surrounds, and some roof trusses survive although the surfaces are somewhat degraded.

There is a cluster of three slightly more ephemeral marks to the western-most arched timber framework. These too exhibit the teardrop shape, but there is little charring to the timber surface, although there is some depth to the marks, and the oak graining is apparent. Groupings of taper burns/scorch marks are significant and probably referenced Christian belief and symbolism: groups of three represented the Holy Trinity, while clusters of five reflect the five wounds of Christ, and seven, the number of gifts of the spirit. Dean and Hill have also noted the occurrence of paired marks within two vernacular buildings at Dennington and Peasehall, Suffolk.²¹

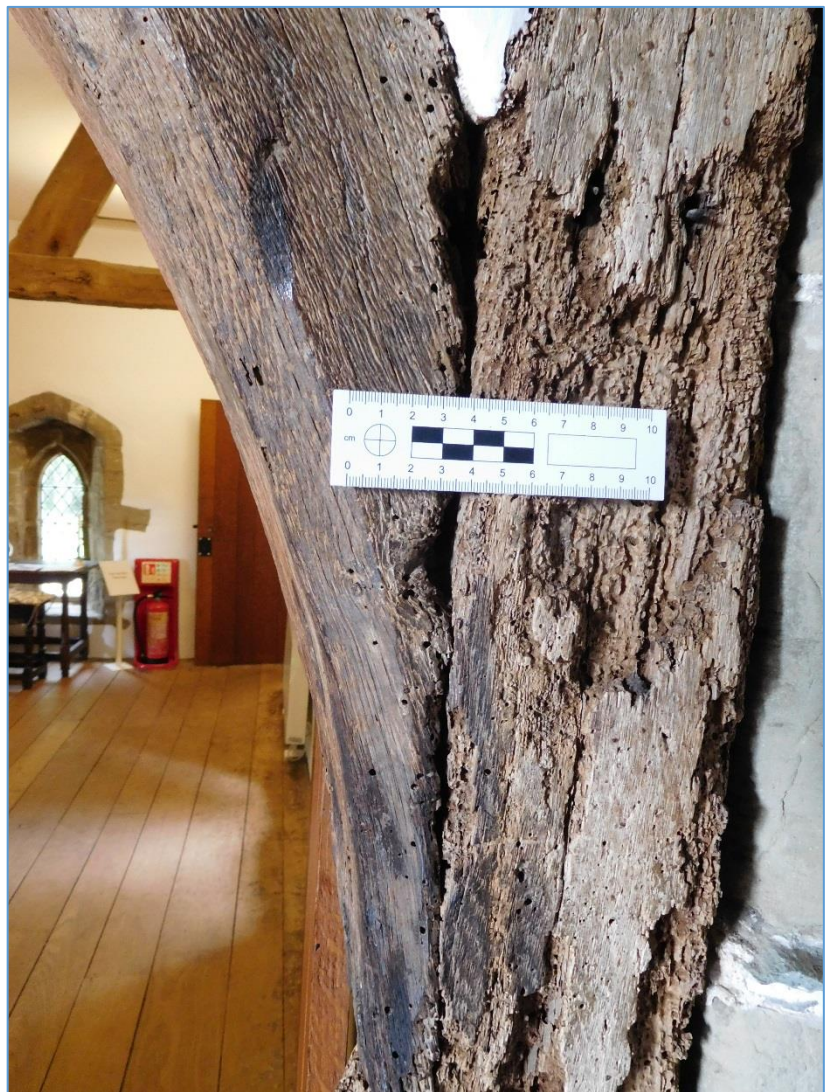
Figure 8 West wing doorway degraded timber, Donington le Heath, Leicestershire. Photo: author.

The eastern-most side of the doorway has fewer burn marks than the western side, these number approximately four, and are not teardrop in shape, but longer scorch marks, again appearing to cross seasoning cracks. It is worth observing that there is partial destruction of the lower part of the doorway, in part due to old woodworm infestation which has degraded the surface significantly. As a result, there is some loss of timber depth, making it impossible to ascertain if there were further scorching events. (fig. 8)

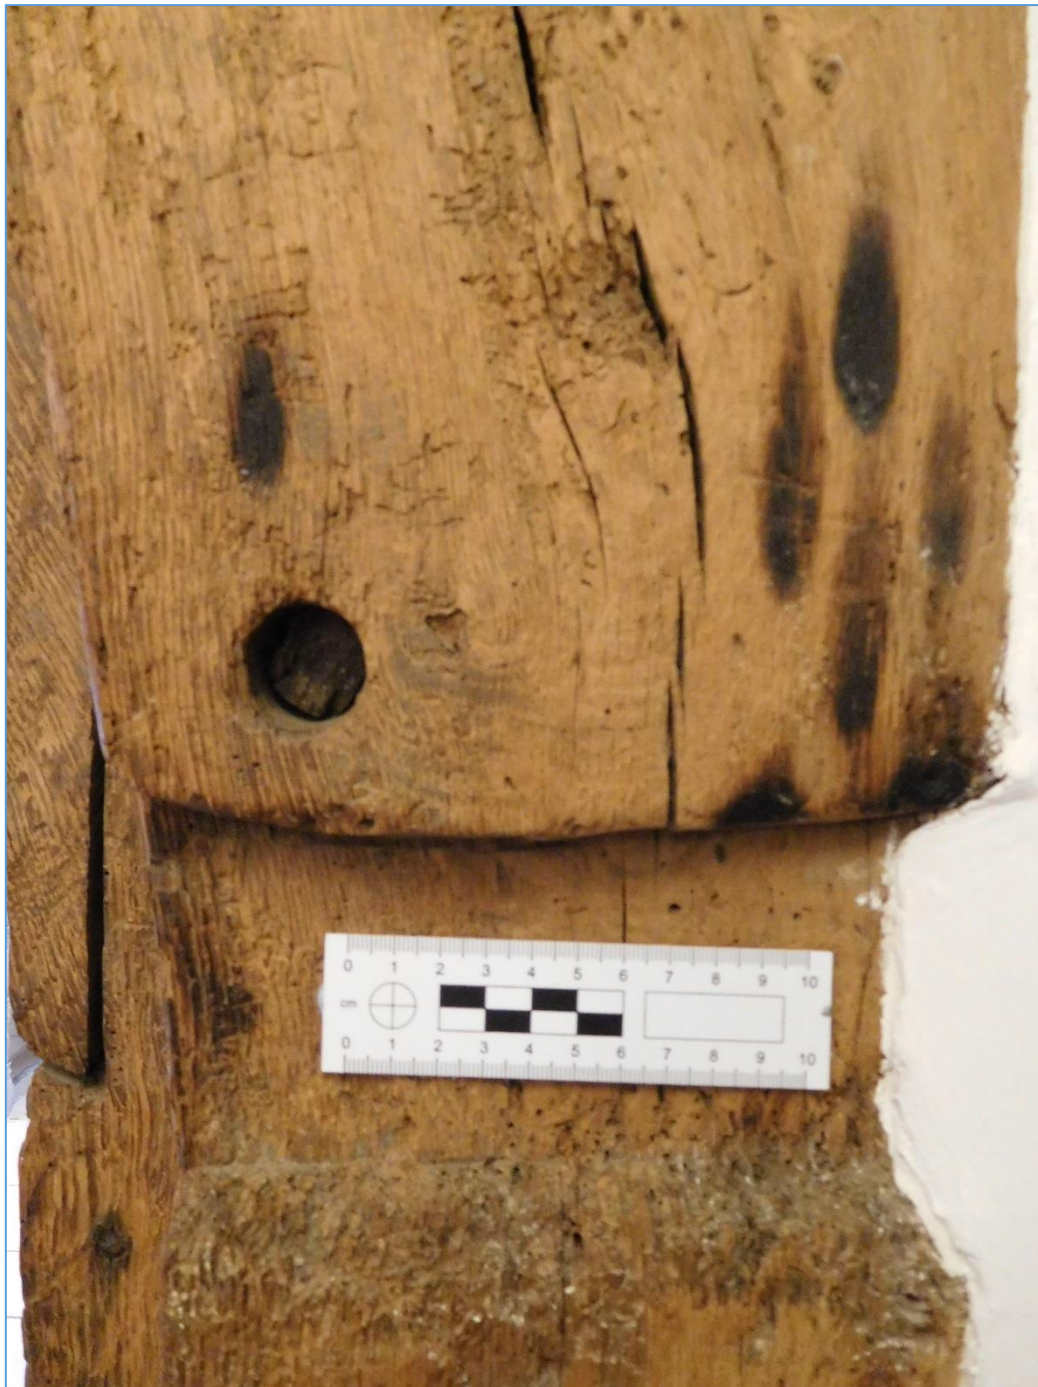
Figure 9 Taper burns west doorway facing into bedchamber, Donington le Heath, Leicestershire. Photo: author.

Here, the highest concentration of burn marks occur on the western-most door jamb, and number approximately ten separate scorching events. These extensive burn marks cross seasoning cracks, and have been distorted by the cracks themselves, indicative of being applied on or shortly after construction. These do not follow the teardrop form being long and deeply scorched, they are of probable 13th century date. There is also an intact planked door with 17th-century metalwork hinges and latch that is devoid of any burn events, though it bears the remnants of various paint colors that once covered it. The burn marks in the

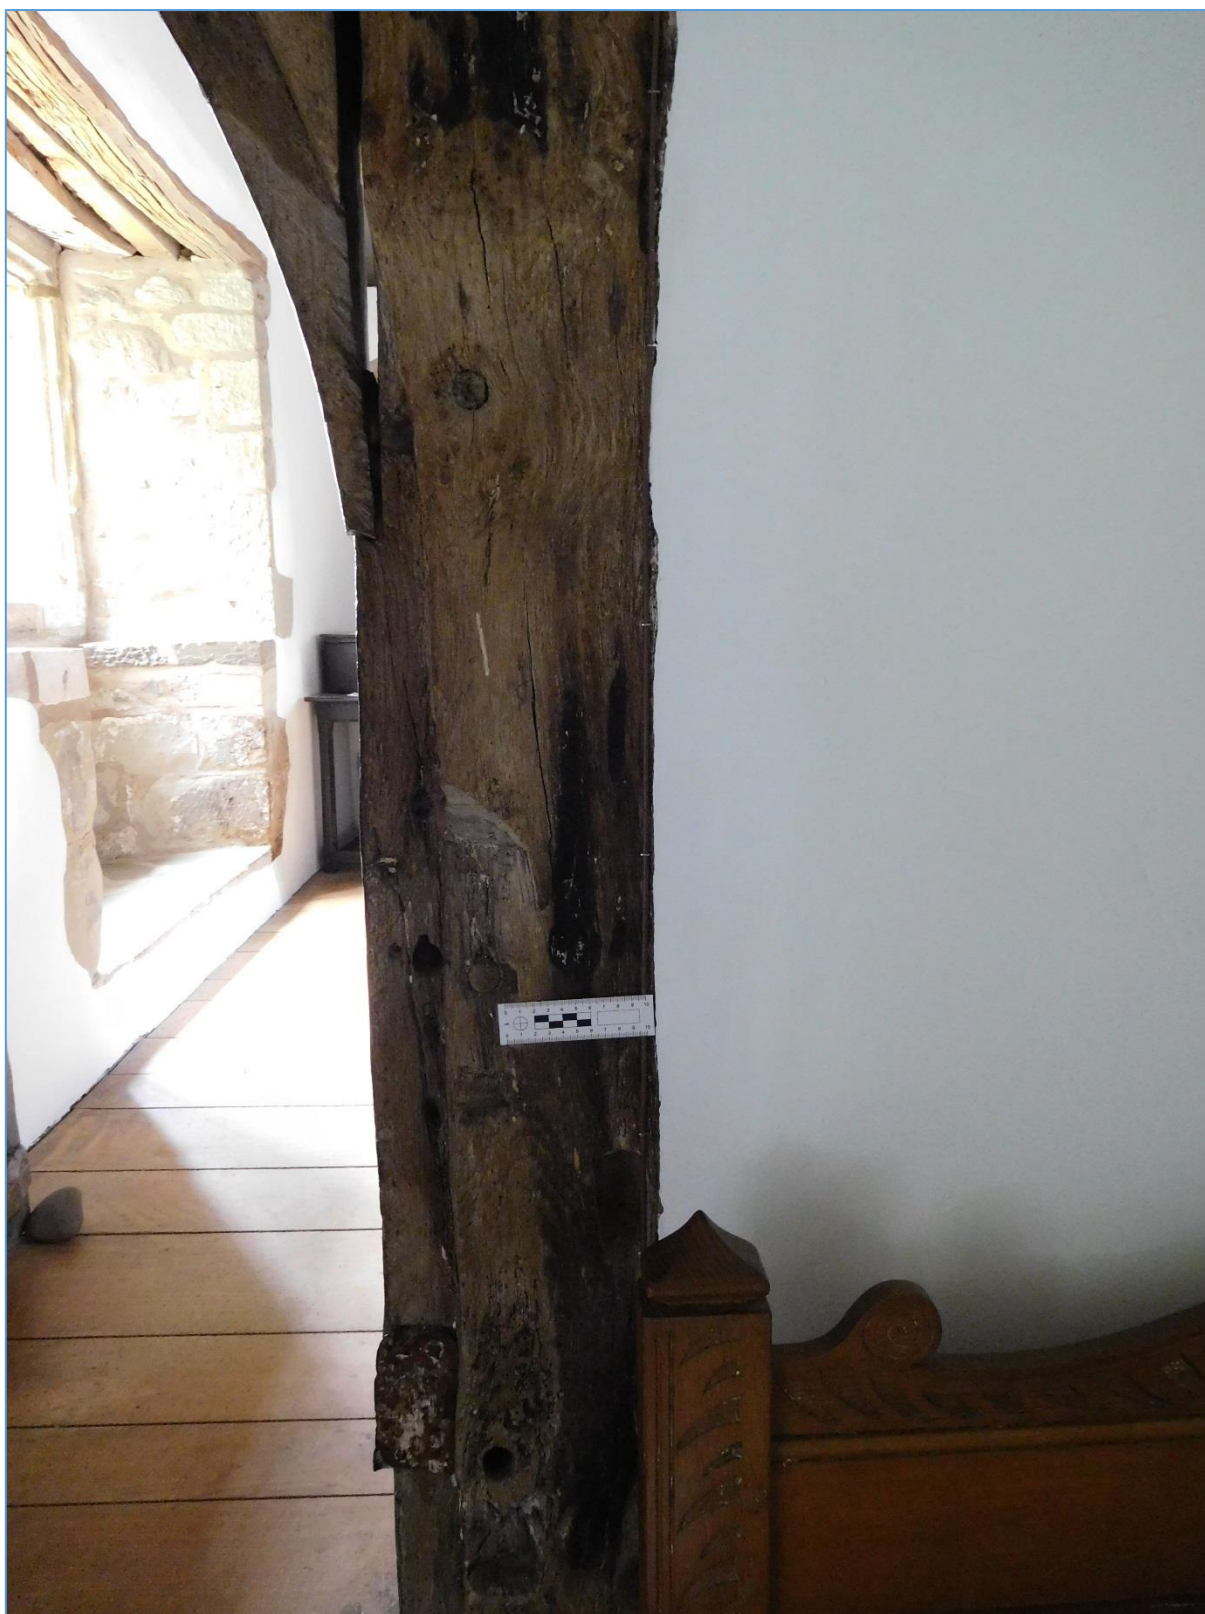
Figure 10 East doorway with taper burns facing bedchamber, Donington le Heath, Leicestershire. Photo: author.

There is a further 13th-century doorway to the eastern wing. Here the burn marks are only concentrated on the interior jambs which face into the bedchamber, and there are no corresponding marks which face into the public area of the Great Hall. The eastern wing consists of only one room, which is an intact 13th-century bedchamber which contains the largest concentration of surviving medieval framework. **(figs. 10, 11)** The original 13th-century roofline can be ascertained owing to the survival of a roof timber, the terminal end of which remains in situ in the eastern most wall.

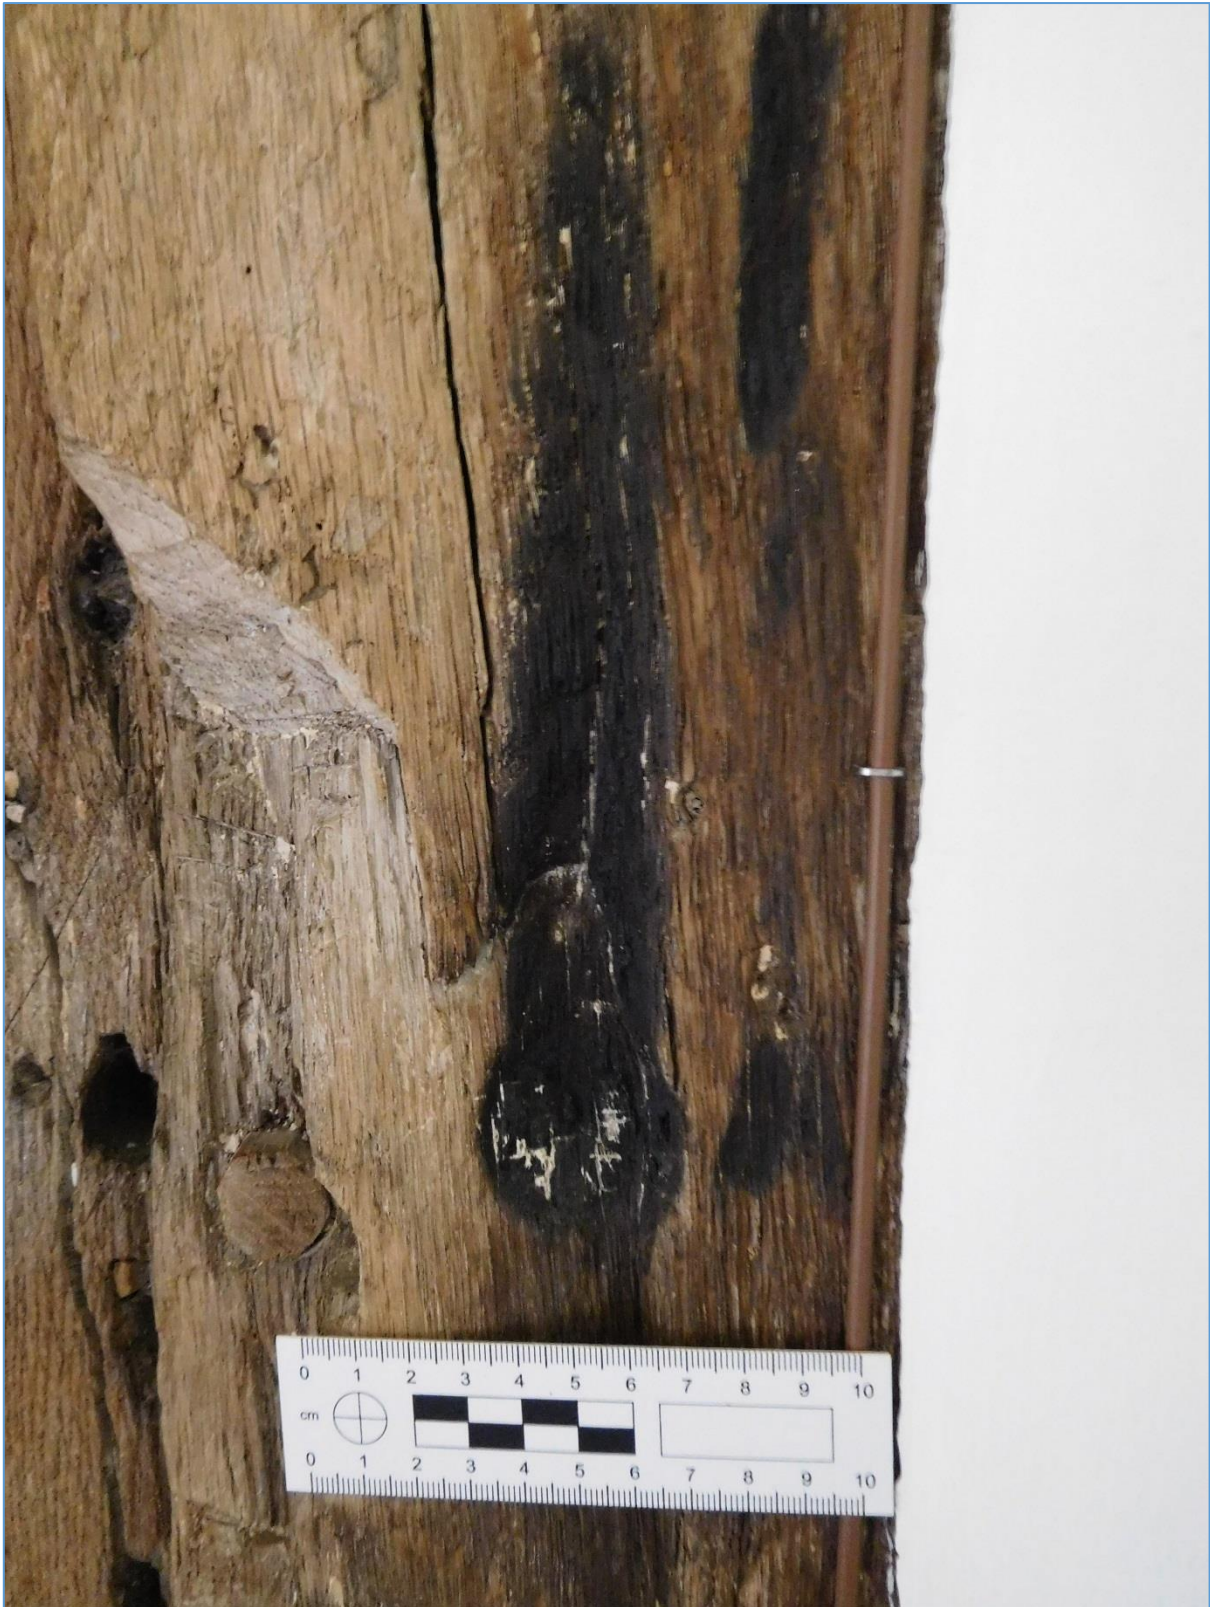
Figure 11 Taper burn east wing doorway facing into bedchamber, Donington le Heath, Leicestershire. Photo: author.

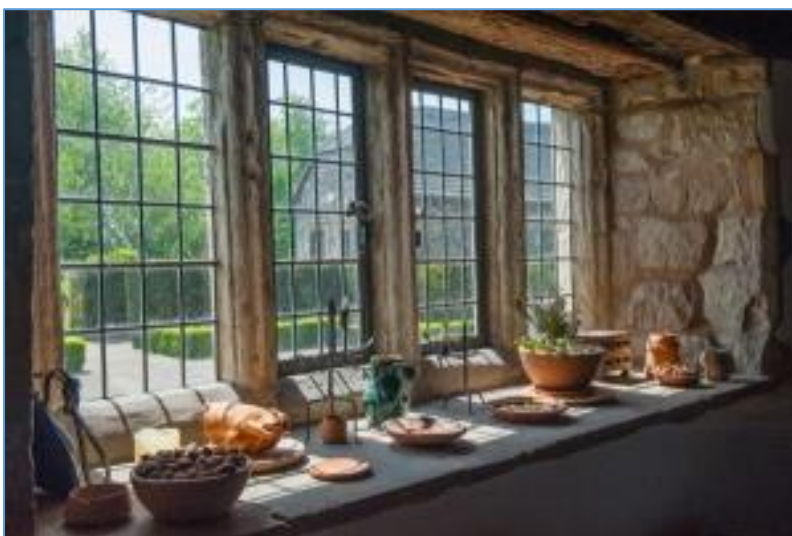
Figure 12 South window, kitchen, Donington le Heath, Leicestershire. Photo: author.

The kitchen taper burns differ significantly to those found on the first-floor doorways. Here they are confined to the supporting lintels above the three-and -four-light mullioned windows. As these are 17th century, the taper burns can be securely dated to that period, more precisely to the 1614-1618 renovations. The taper burn marks are concentrated on the reused oak timber framing, comprising the window lintel, some of which is socketed, and although these have not been dated by dendrochronology, it is likely that these are reused medieval timbers. The scorch marks on the timbers do not conform to the teardrop shape of the other marks within the building. It suggests that these timbers have been marked in situ following the renovations and modernizations in the early 17th century. With the timbers in a horizontal position, the teardrop shape would have been impossible to replicate.

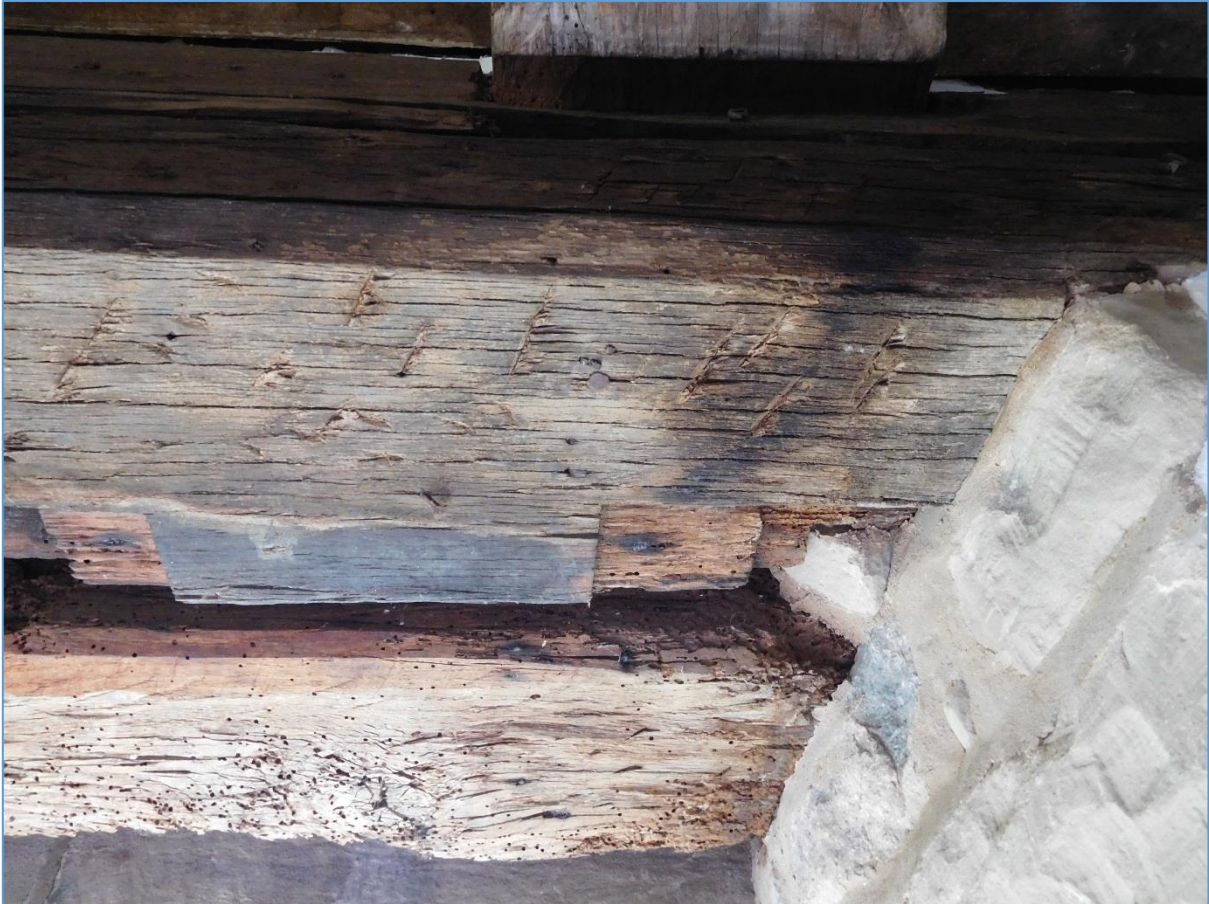
Figure 13 Taper burn, south kitchen window, Donington le Heath, Leicestershire. Photo: author.

The south window has taper burns which have been applied to both right and left sides of the supporting lintels, and the east-facing mullioned window has burn marks found only on the left or north side of the timbers. (**fig. 13**) These timber lintels show no evidence of repeat marking. It is probable that, because these timbers had been plastered over, repeat marking was unable to be performed.
