## EPV 030 Goodwin Field Notes 2007

Whitney Goodwin

## Structure C4 - Initial Goals

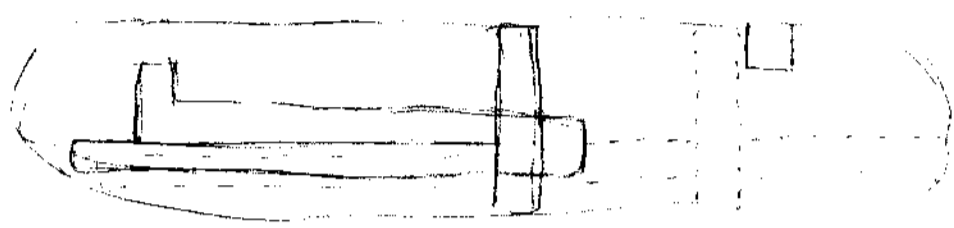
- axial trench on east
- remove poorly preserved terraces
- investigate earlier versions - Early phase?
- follow back wall to the west
- look for stairs
- did the building really face south?
- test pits to the south
- was this a prepared surface?

□ previous  
○ planned

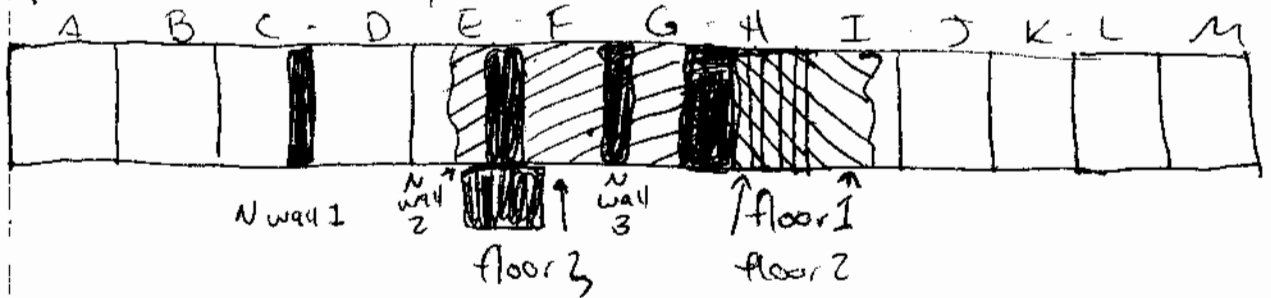
We are already seeing two phases of construction. The first consisting of the floor that begins in EU E along with the door jamb in EU F. These were both then covered by the floor visible in EU I and the base of the wall visible in EU E. This floor level probably extended to the terrace visible in EU C and a back wall still to be found somewhere in EU J. The floor is only preserved out to EU I because it has a steady base formed by the back wall in the first phase of construction. There is no clear edge to the floors so it is hard to say what happened with them.

The building was expanded to the north and south. The first phase was covered up to the top of the door jambs - forming the new summit and preserving that phase. The last phase is not well preserved and we have probably lost any summit architecture.

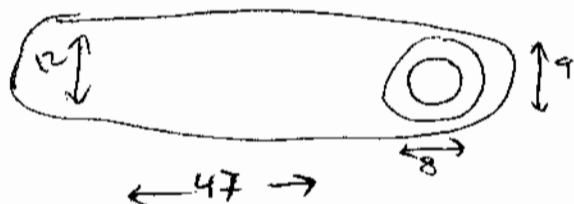
First there was the floor on the summit. A door jamb - the same as those discovered in earlier excavations - was built in from the southern edge of the platform. This platform had a ledge and then dropped down to the stone floor. In the second phase they filled up to the top of the door jamb going north on the same floor. To the south they extended the floor, covering the back wall - it is unclear if this wall dropped down in one wall or if there was a terrace here. On top of the previous back wall, to the south of the door jamb, there may have been an open space between a more southern wall and the jamb that was later filled in with the material found in EU N. But, there is also a very large root that runs through this space that might have caused the rocks to fall like they did.

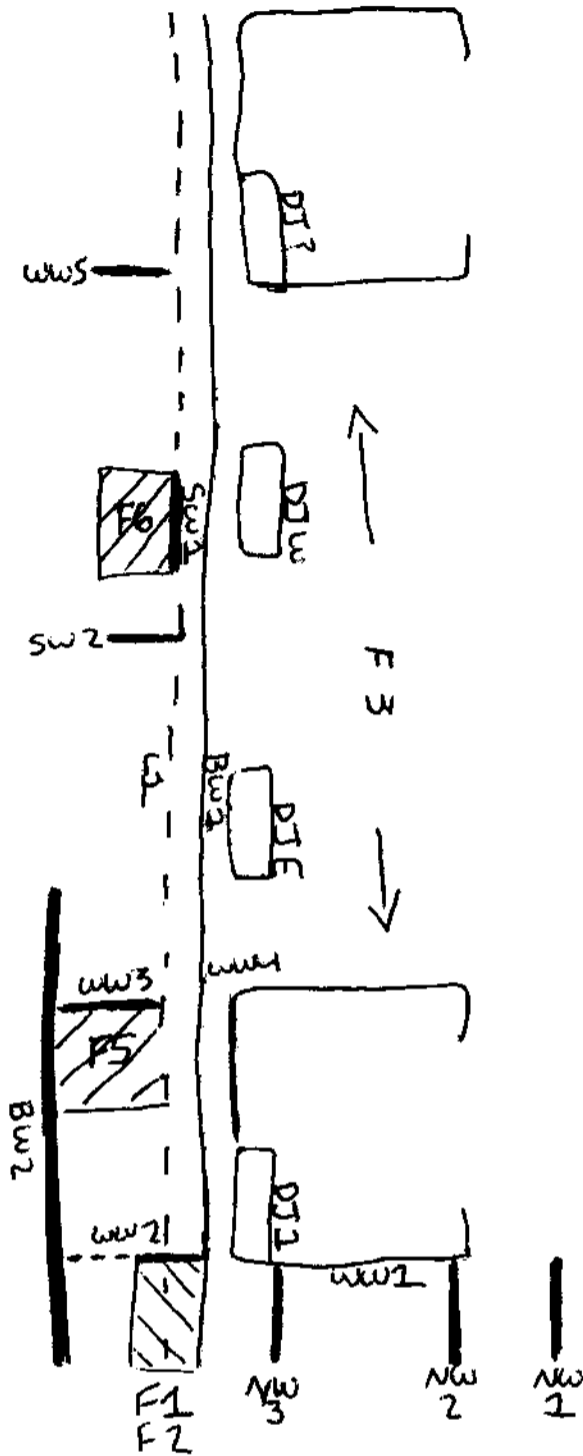
- ① BW2, L1, F5, F3
- ② DJ1, DJE, DJW, DJ?
- ③ WW1, WW4
- ④ WW3, WW5
- ⑤ F2, BW2(F4)
- ⑥ F1, NW3, NW2, WW2
- ⑦ SW1, F6, SW2
